# Manhole Inspection Summary

Manhole # S33Q\_\_028MH

Insp Date: **3/17/08 11:32 AM**

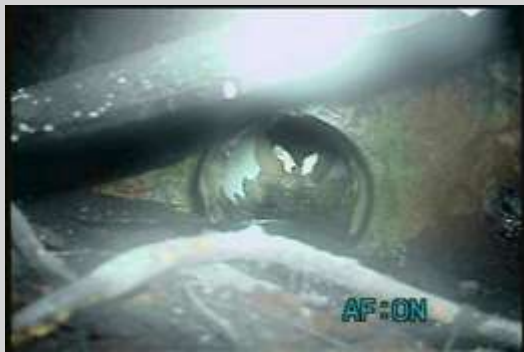
12 O'Clock Outflow

8 in. Circular Gravity Sewer  
Pipe Out @ 12 O'Clock

Infiltration: **None** Pipe Seal Cond: **Unknown**
